**Hawaii Biological Survey, Bishop Museum, Observations and Findings from 7 April 2003  
Site Visit of Unnamed Stream Flowing into Pila'a Bay, Kaua'i**

**Prepared for:  
Earth Tech  
841 Bishop Street, Suite 500  
Honolulu, HI 96813**

**Prepared by:  
R.A. Englund, Aquatic Ecologist  
Hawaii Biological Survey  
Bishop Museum  
Honolulu, Hawai'i 96817**

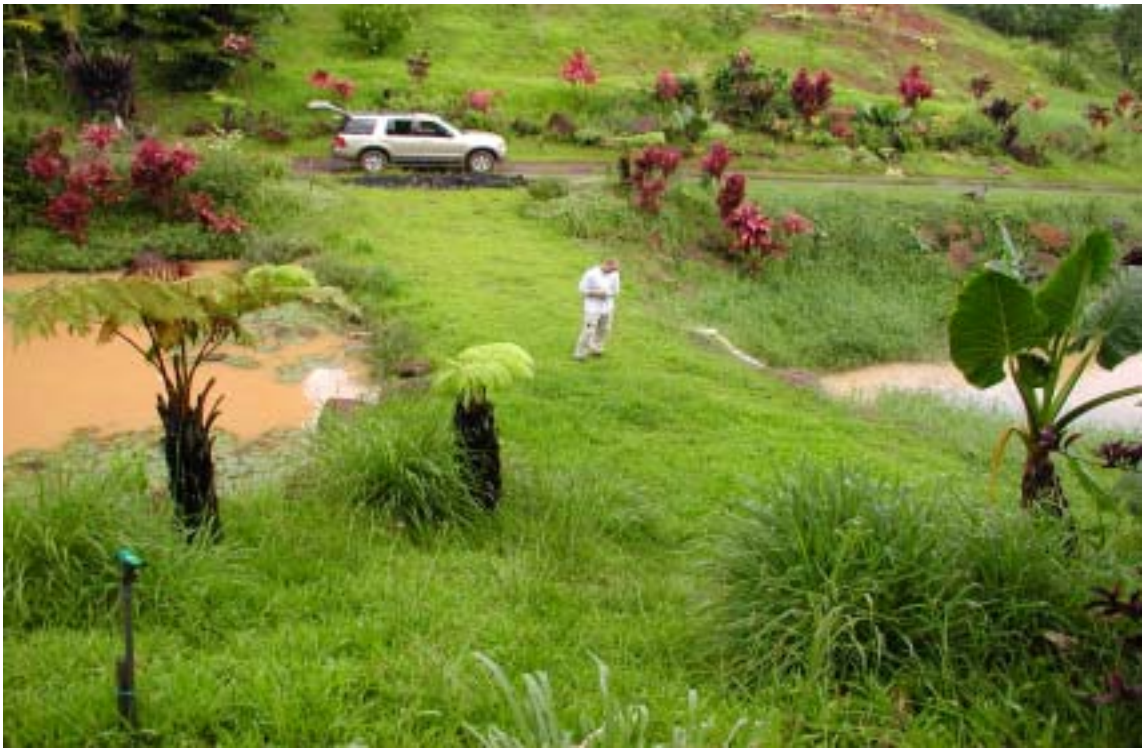
Photo 1. The landscaped areas around Pond 2 and Pond 3 appear to be stable. Note the 6" PVC pipe connecting the ponds under the grassed causeway (Photo 3 shows a different angle of the discharge end).

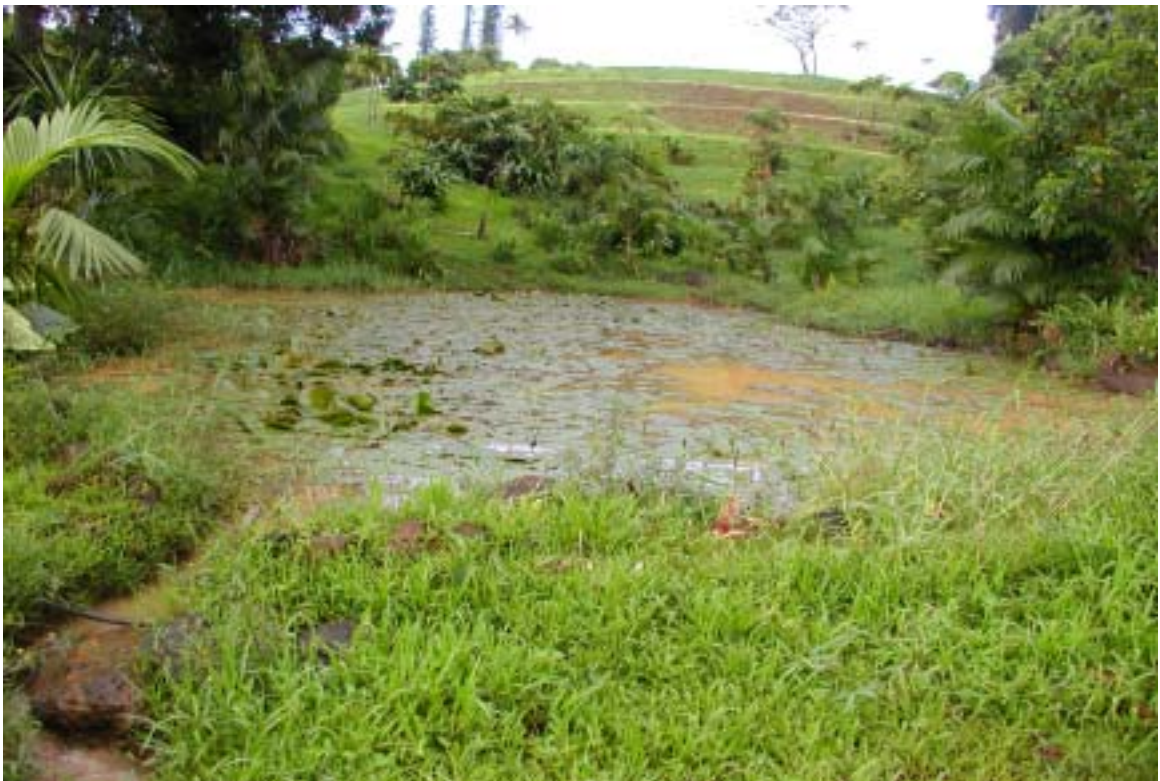
Photo 2. The banks of Pond 1 appear to be stable. Note turbidity from recent surface flow, water lilies and small streamlet connecting Pond 1 with Pond 2.

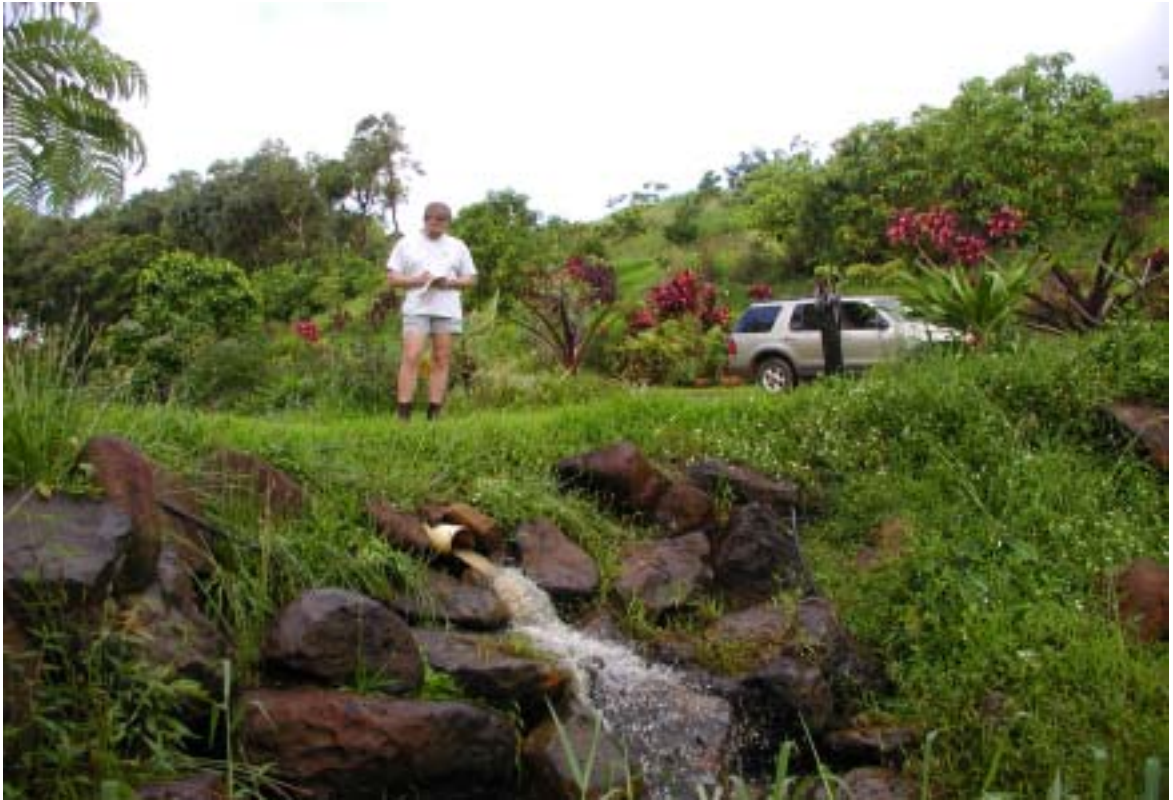
Photo 3. Six-inch PVC discharge pipe form Pond 2 into Pond 3.

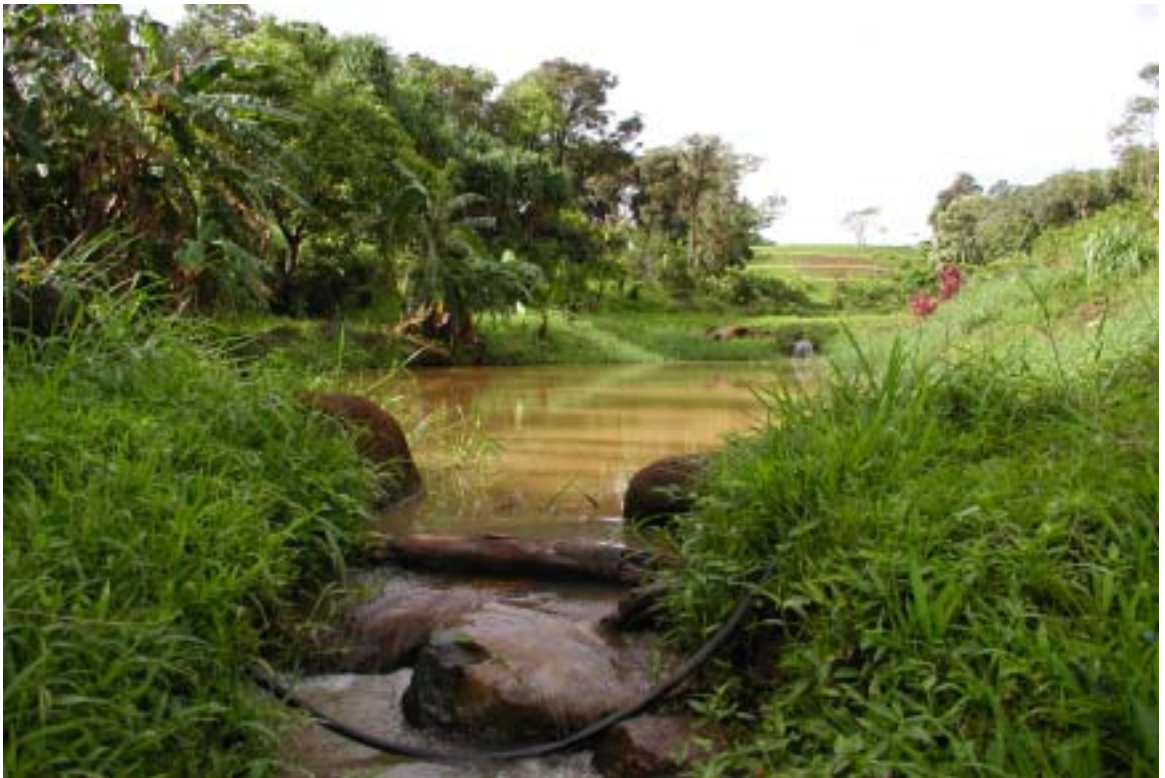
Photo 4. Pond 4 and streamlet outlet.

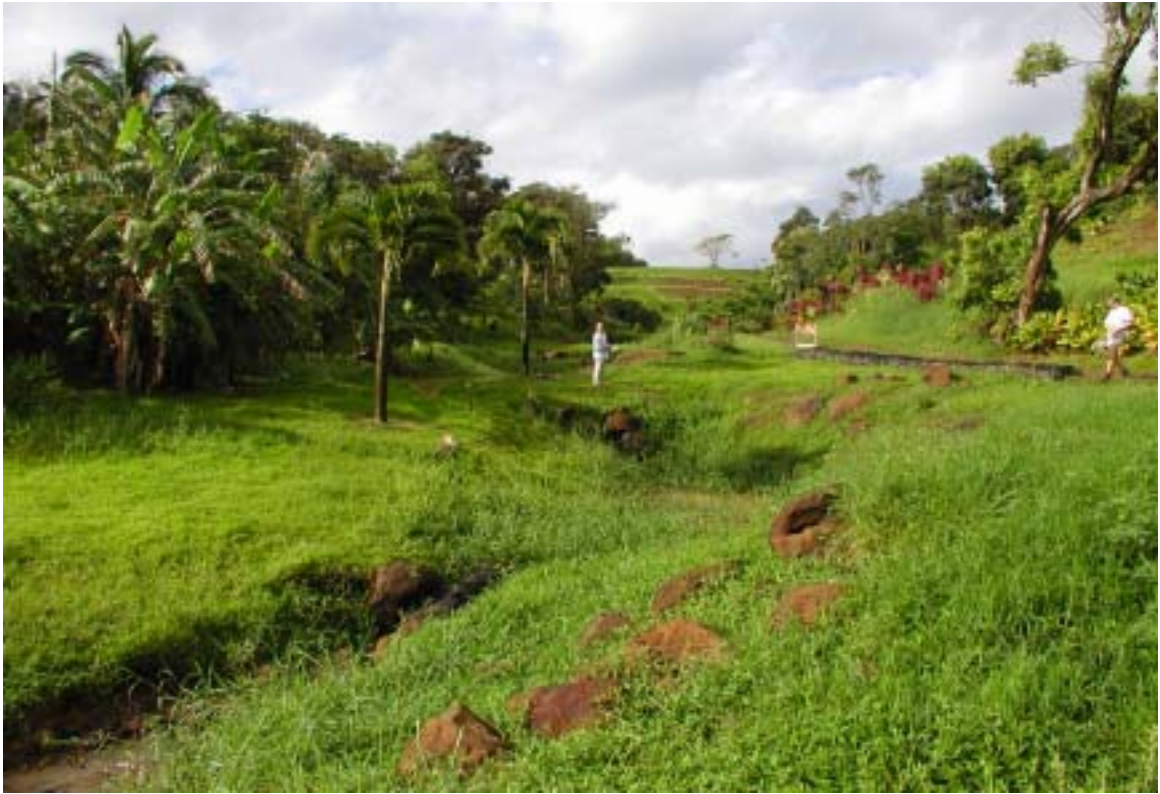
Photo 5. The streamlet from Pond 4 to Pond 5 meandering through the topography.

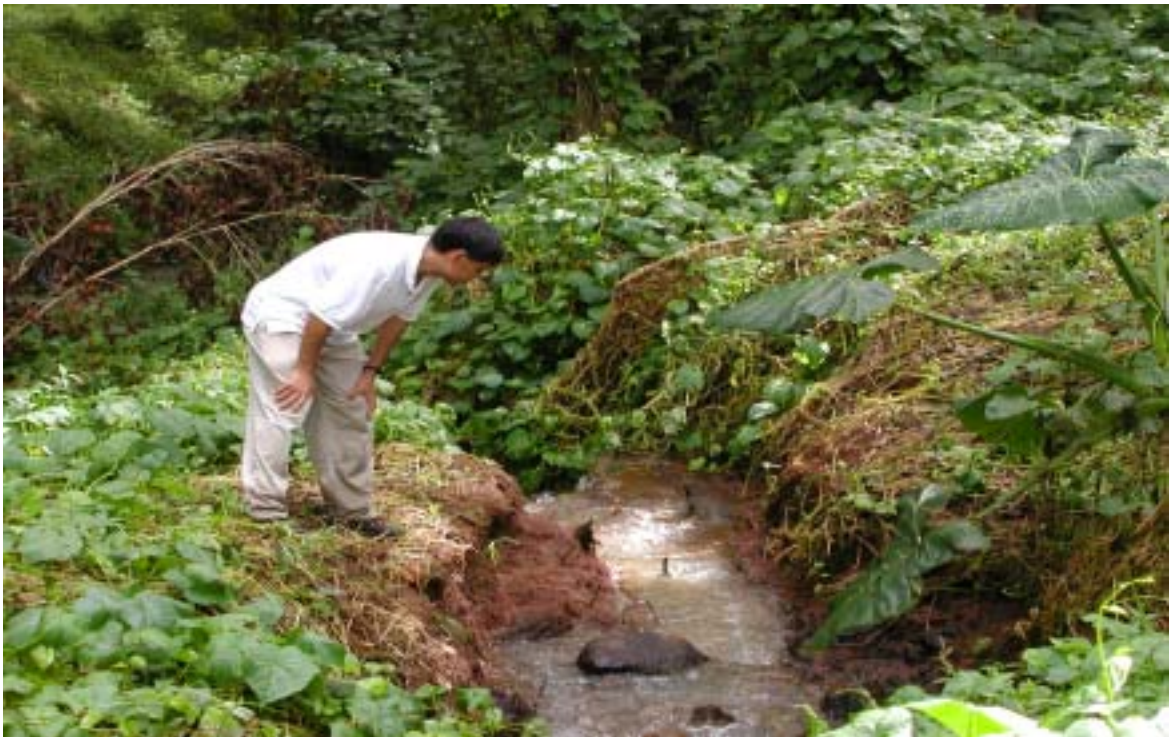
Overall, the aquatic fauna found in the Gulch 3 seven pool area is a mixture of native and introduced species representative of impoundments. The finding of the scarlet Kauai damselfly (*Megalagrion vagabundum*) in the stream outlet draining the lowest of the seven pools was especially surprising, and at 80 foot elevation is possibly one of the lowest elevation records in recent times for this increasingly rare endemic damselfly. It is possible that this damselfly species continues to inhabit areas that the alien fish species are unable to access in the fast-water velocity spillway below the lowest pond (Photo 6).

Photo 6. General location at the outlet of Pond 7 where the endemic scarlet Kauai damselfly was sited. The discharge channel of the lowest pond (Pond 7) in Gulch 3 shows signs of erosion.

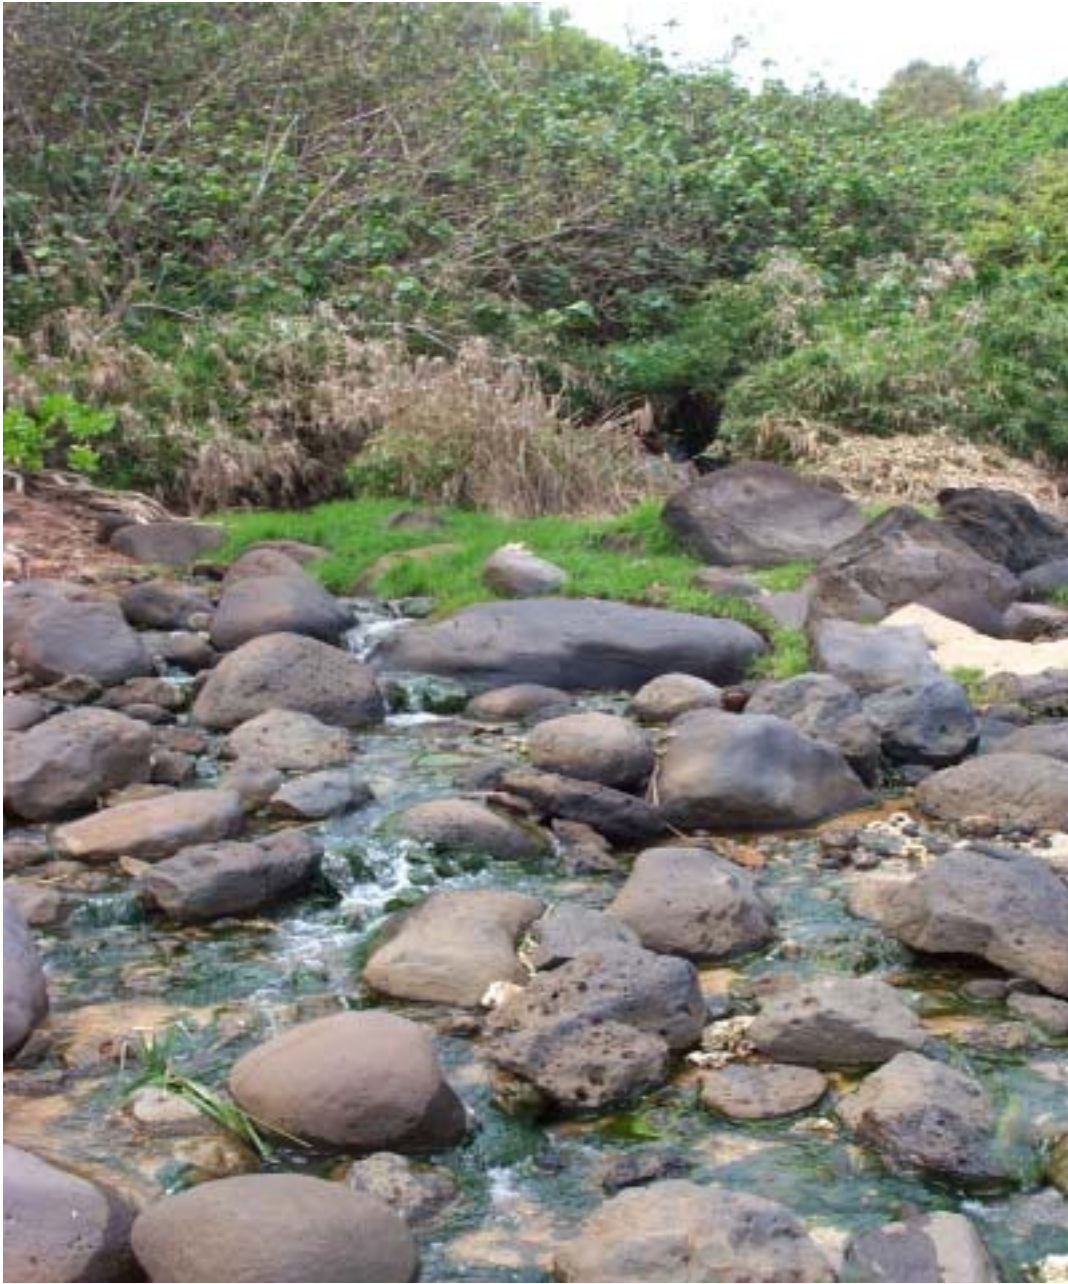
Photo 7. Lower stream reaches from seven ponds area emerging from Hau Tree thicket

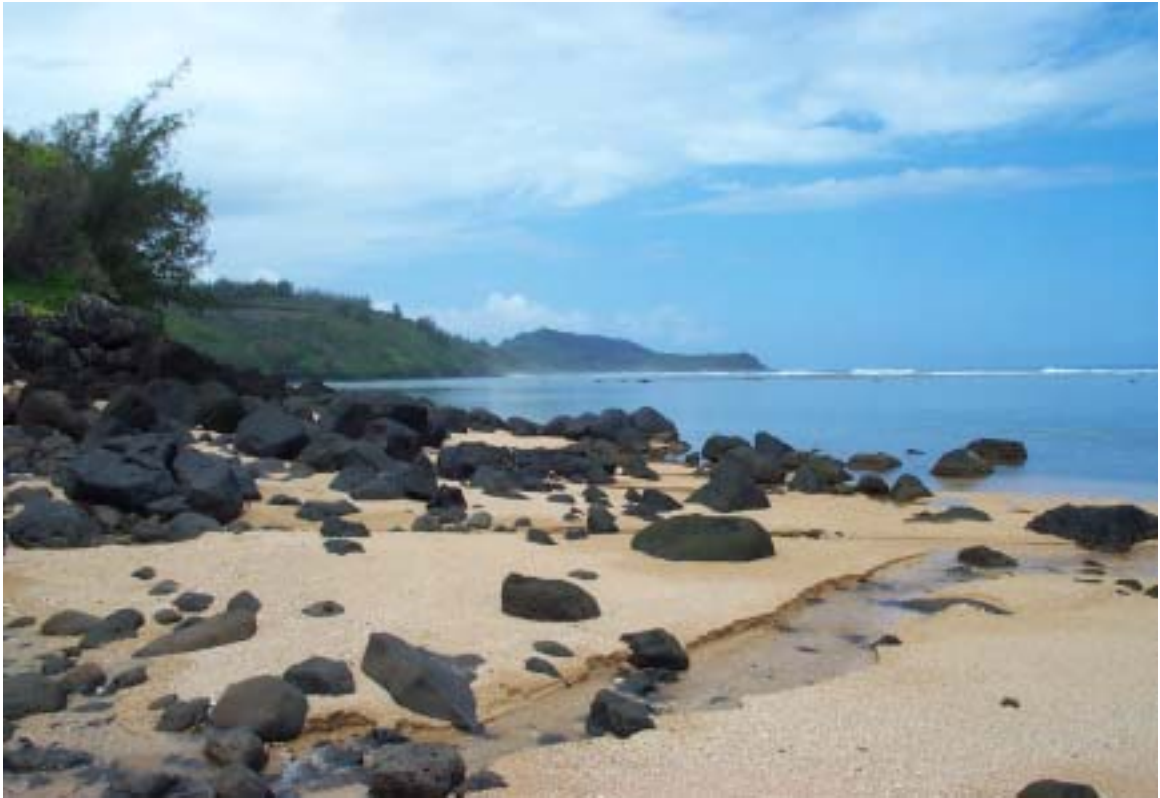
Photo 8. Lower stream reaches from seven ponds area as it enters the ocean.

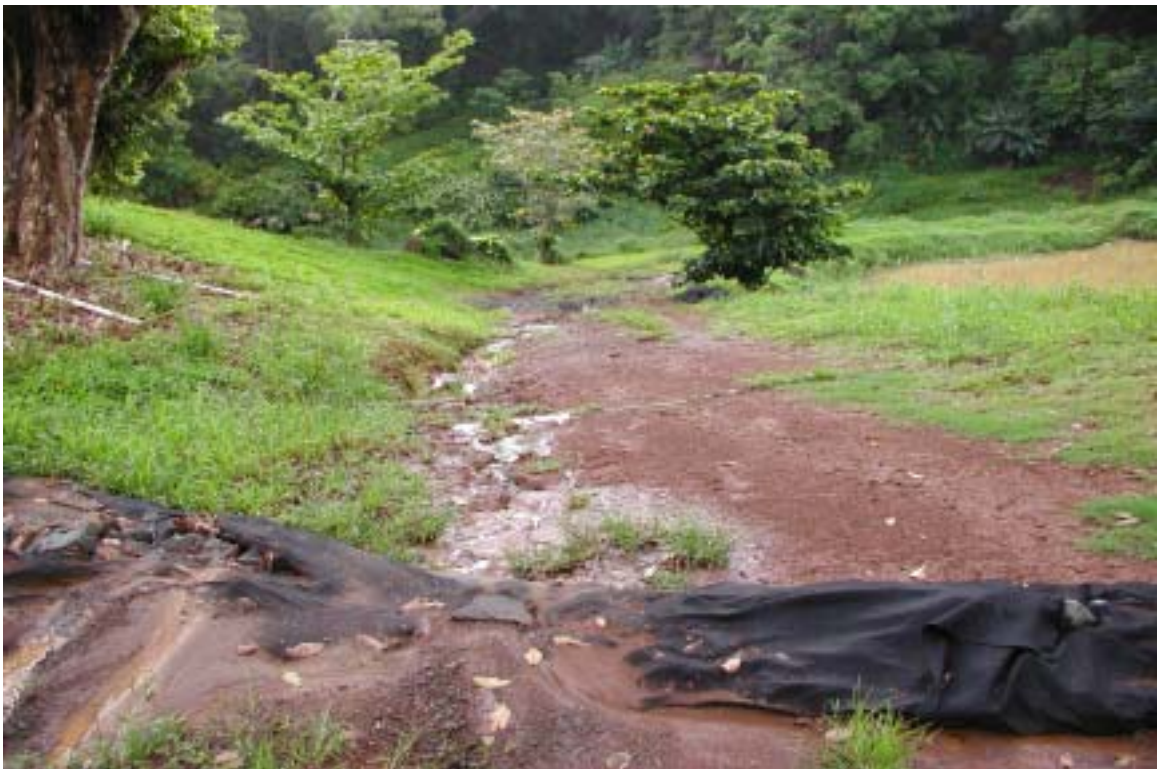
Photo 9. Erosion on jeep trails in Gulch 3. Note that the rock filter berm is ineffective in preventing erosion and sediment is carried over the berm toward Pond 6 and 7 (Pond 6 is in the background on the right side).

could occur through the installation of several small nesting islands in the ponds. If the ponds were removed, few long-term benefits to other native species such as ‘o‘opu or other stream species would accrue because of the prevalence of other introduced fish species in this stream area, and it would also eliminate prime habitat for several Federally endangered waterbird species. Short to medium-term harm by increased sedimentation would occur to stream and reef species while trying to restore the stream channel to its former geomorphology, and could possibly eliminate the native *Megalagrion* damselfly species observed at the lowest pond outlet as well. The caveat for the least harmful to the environment (of not removing the ponds) recommendation option is that effective erosion control techniques need to be implemented. Properly designed, long-term sediment reduction procedures (e.g., road closures, revegetation, proper berms, etc.) and structures need to be put into action. Native plants should be used whenever possible to revegetate hills and closed roads. To ensure effectiveness of this mitigation, long-term monitoring of the new erosion control structures, and sedimentation monitoring should be conducted by a qualified geologist or hydrologist.

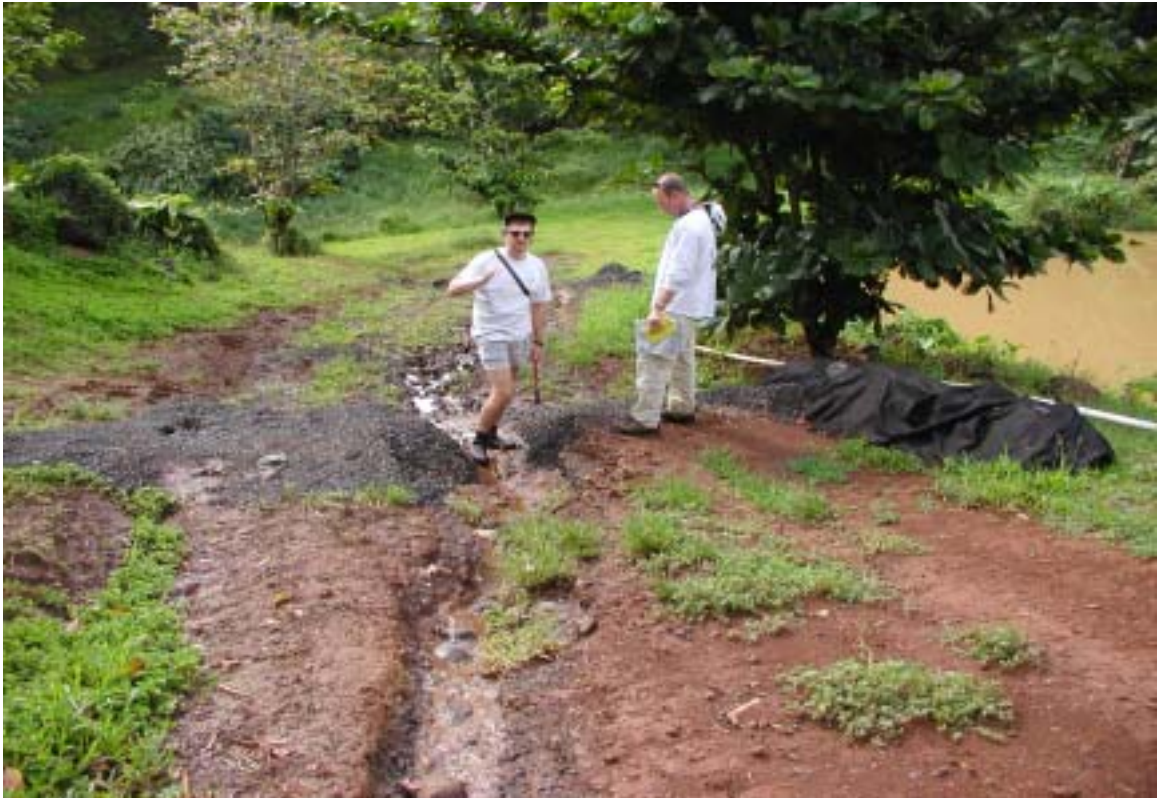
Photo 10. Erosion on jeep trails Gulch 3. Note that the gravel berm is ineffective and has been breached by concentrated runoff along the jeep trail. (Pond 6 is in the background right side).

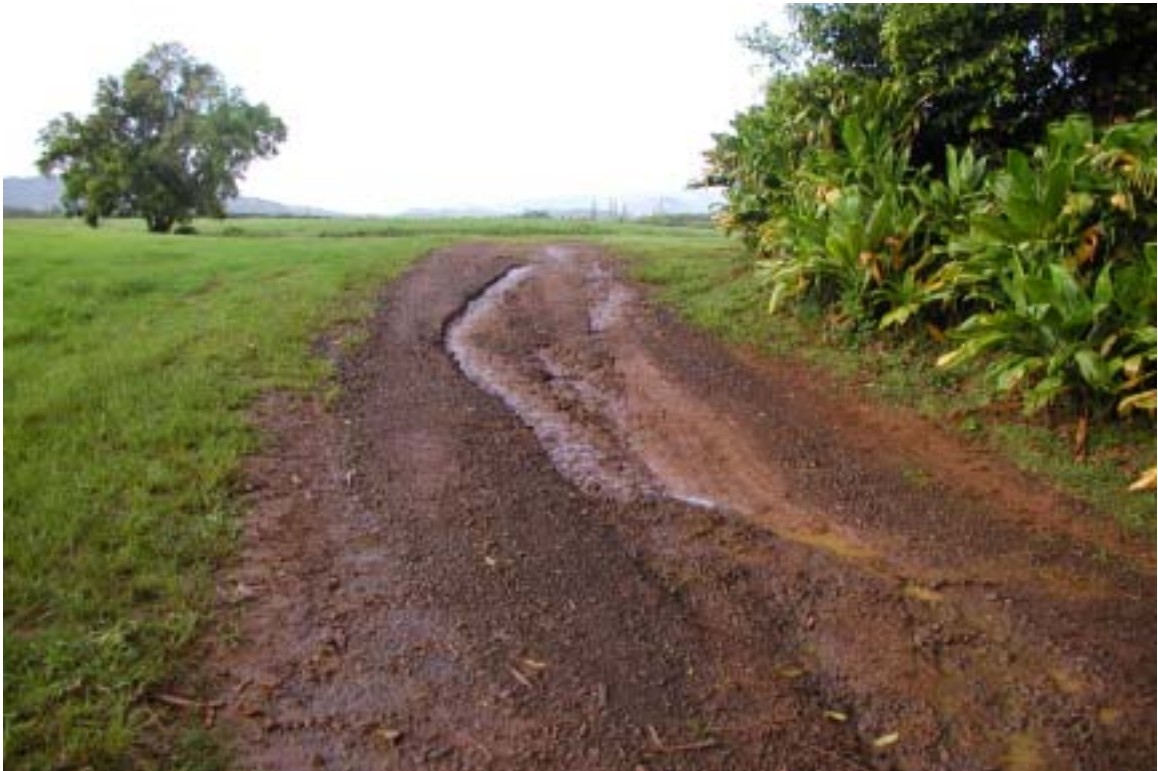
Photo 11. Erosion on jeep trail in Gulch 3 up gradient of Pond 1. The gravel is ineffective in protecting the trail from erosion, and the 18" CMP culvert under this jeep trail near Pond 1 is ineffective at handling storm flow.

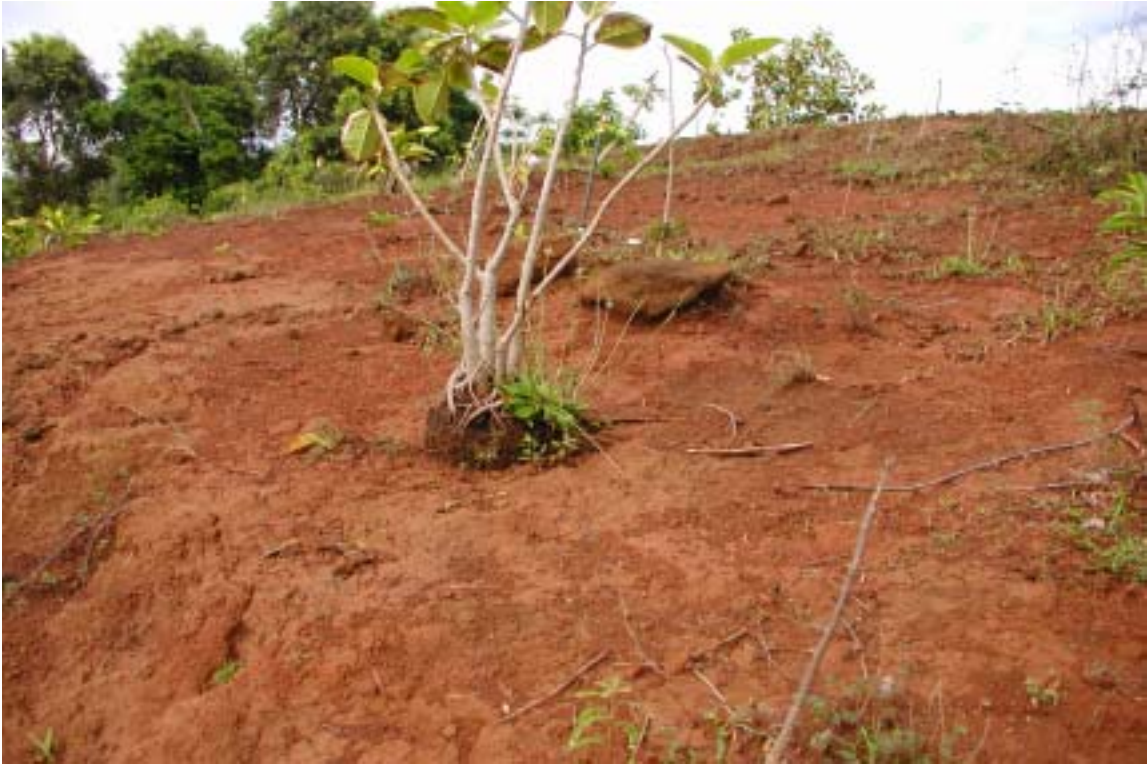
Photo 12. View of erosion on the bare slope close to Ponds 3 and 4 in Gulch 3. Over a half foot of topsoil has been eroded away as indicated by the exposed roots of the shrub in the center of the photo.
